2010 Operations, Maintenance, and Monitoring Report

Hopedale Hydrologic Restoration (PO-24)

State Project Number PO-24

November 29, 2010

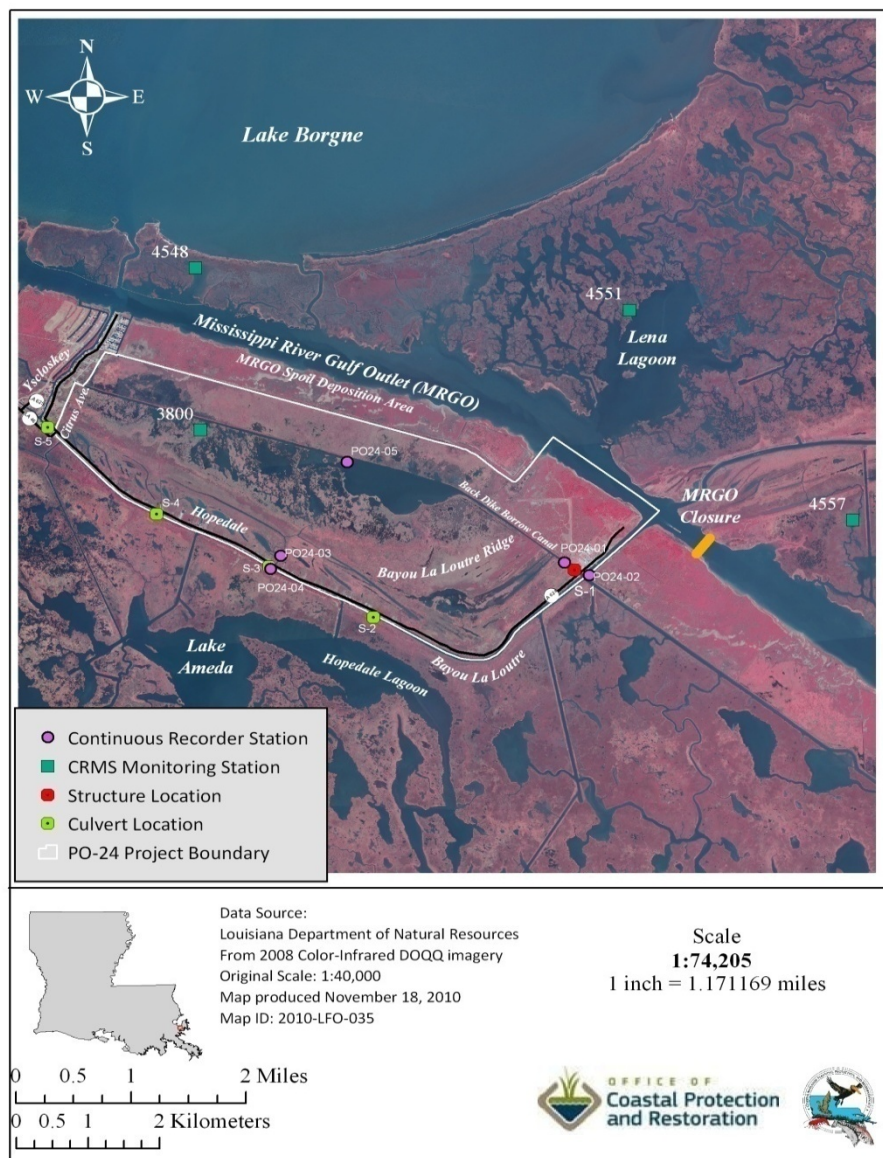
Figure 1. Hopedale Hydrologic Restoration (PO-24) project area map with project features.
